BIO-BLOCK. THE SOLUTION TO FAT AND GREASE DEPOSITS

IMPLEMENTING THE BIO-BLOCK TREATMENT.

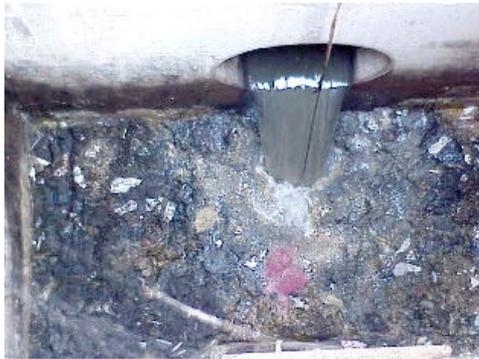
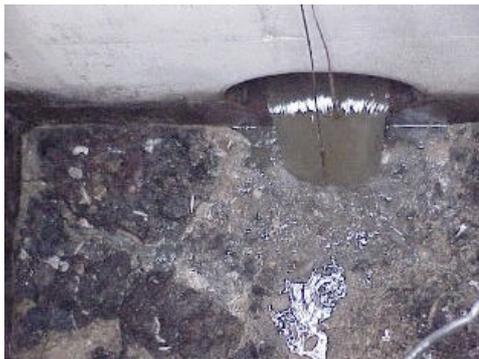
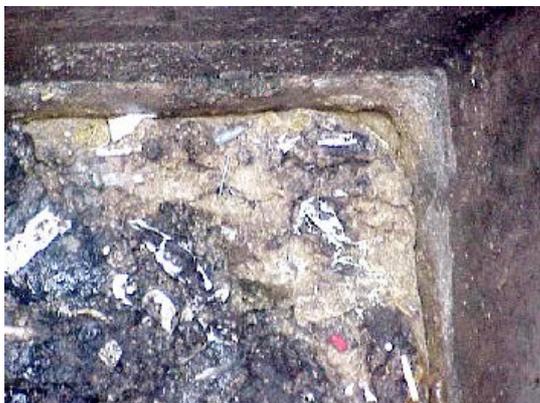
BEFORE

The following pictures show the primary wet well at a pumping station in Europe. The Bio-Block is suspended just below the waste water inlet.

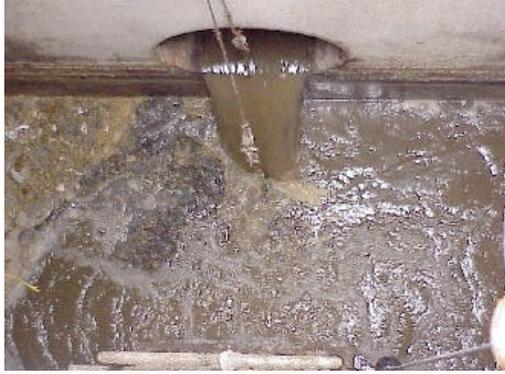
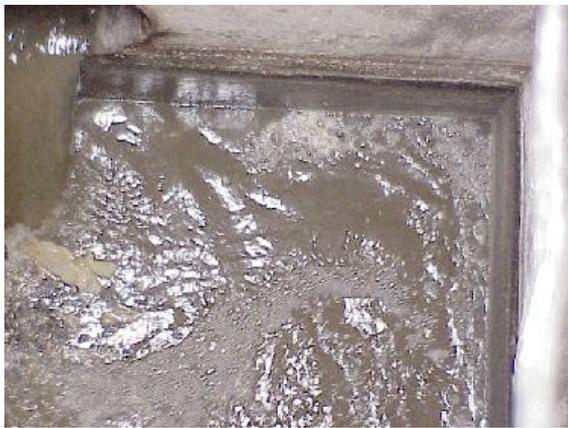
AFTER

The following pictures show the results of treatment with the Bio-Block after only six weeks. With the exception of a small build-up in the upper left hand corner, the well appears to be virtually free of any fat or grease.

Though the active ingredients of the Bio-Block are effective immediately, it's full effects are not seen for three to four weeks. This is due to the bacteria having to colonise, proliferate and penetrate the fat build-up. In fact, during this phase, more fat and grease may appear to be present as a result of old fat and grease deposits being freed and deposited in the system.
